MAGNOLIA PIER CONDITION ASSESSMENT REPORT MAGNOLIA HARBOR Gloucester, Massachusetts

June 2018

File No. 18.0173724.00

GZA GeoEnvironmental, Inc.

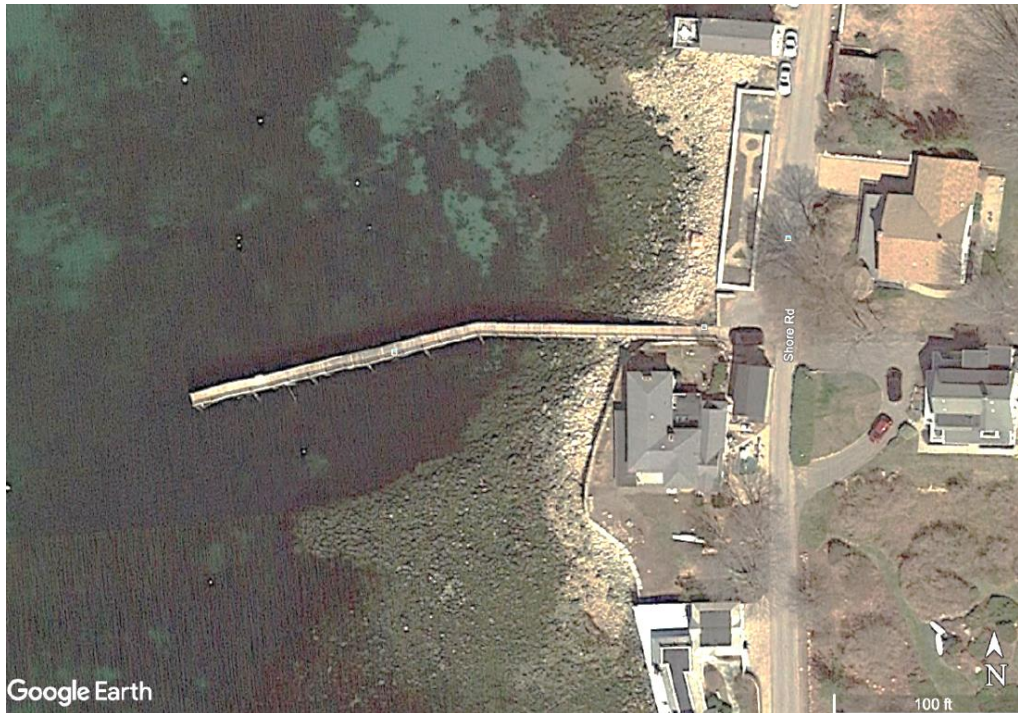
| Photo No. 1 | Date: 5/2018 | | |

| Description: Google Earth Image of Magnolia Pier Source: Google Earth | | | |

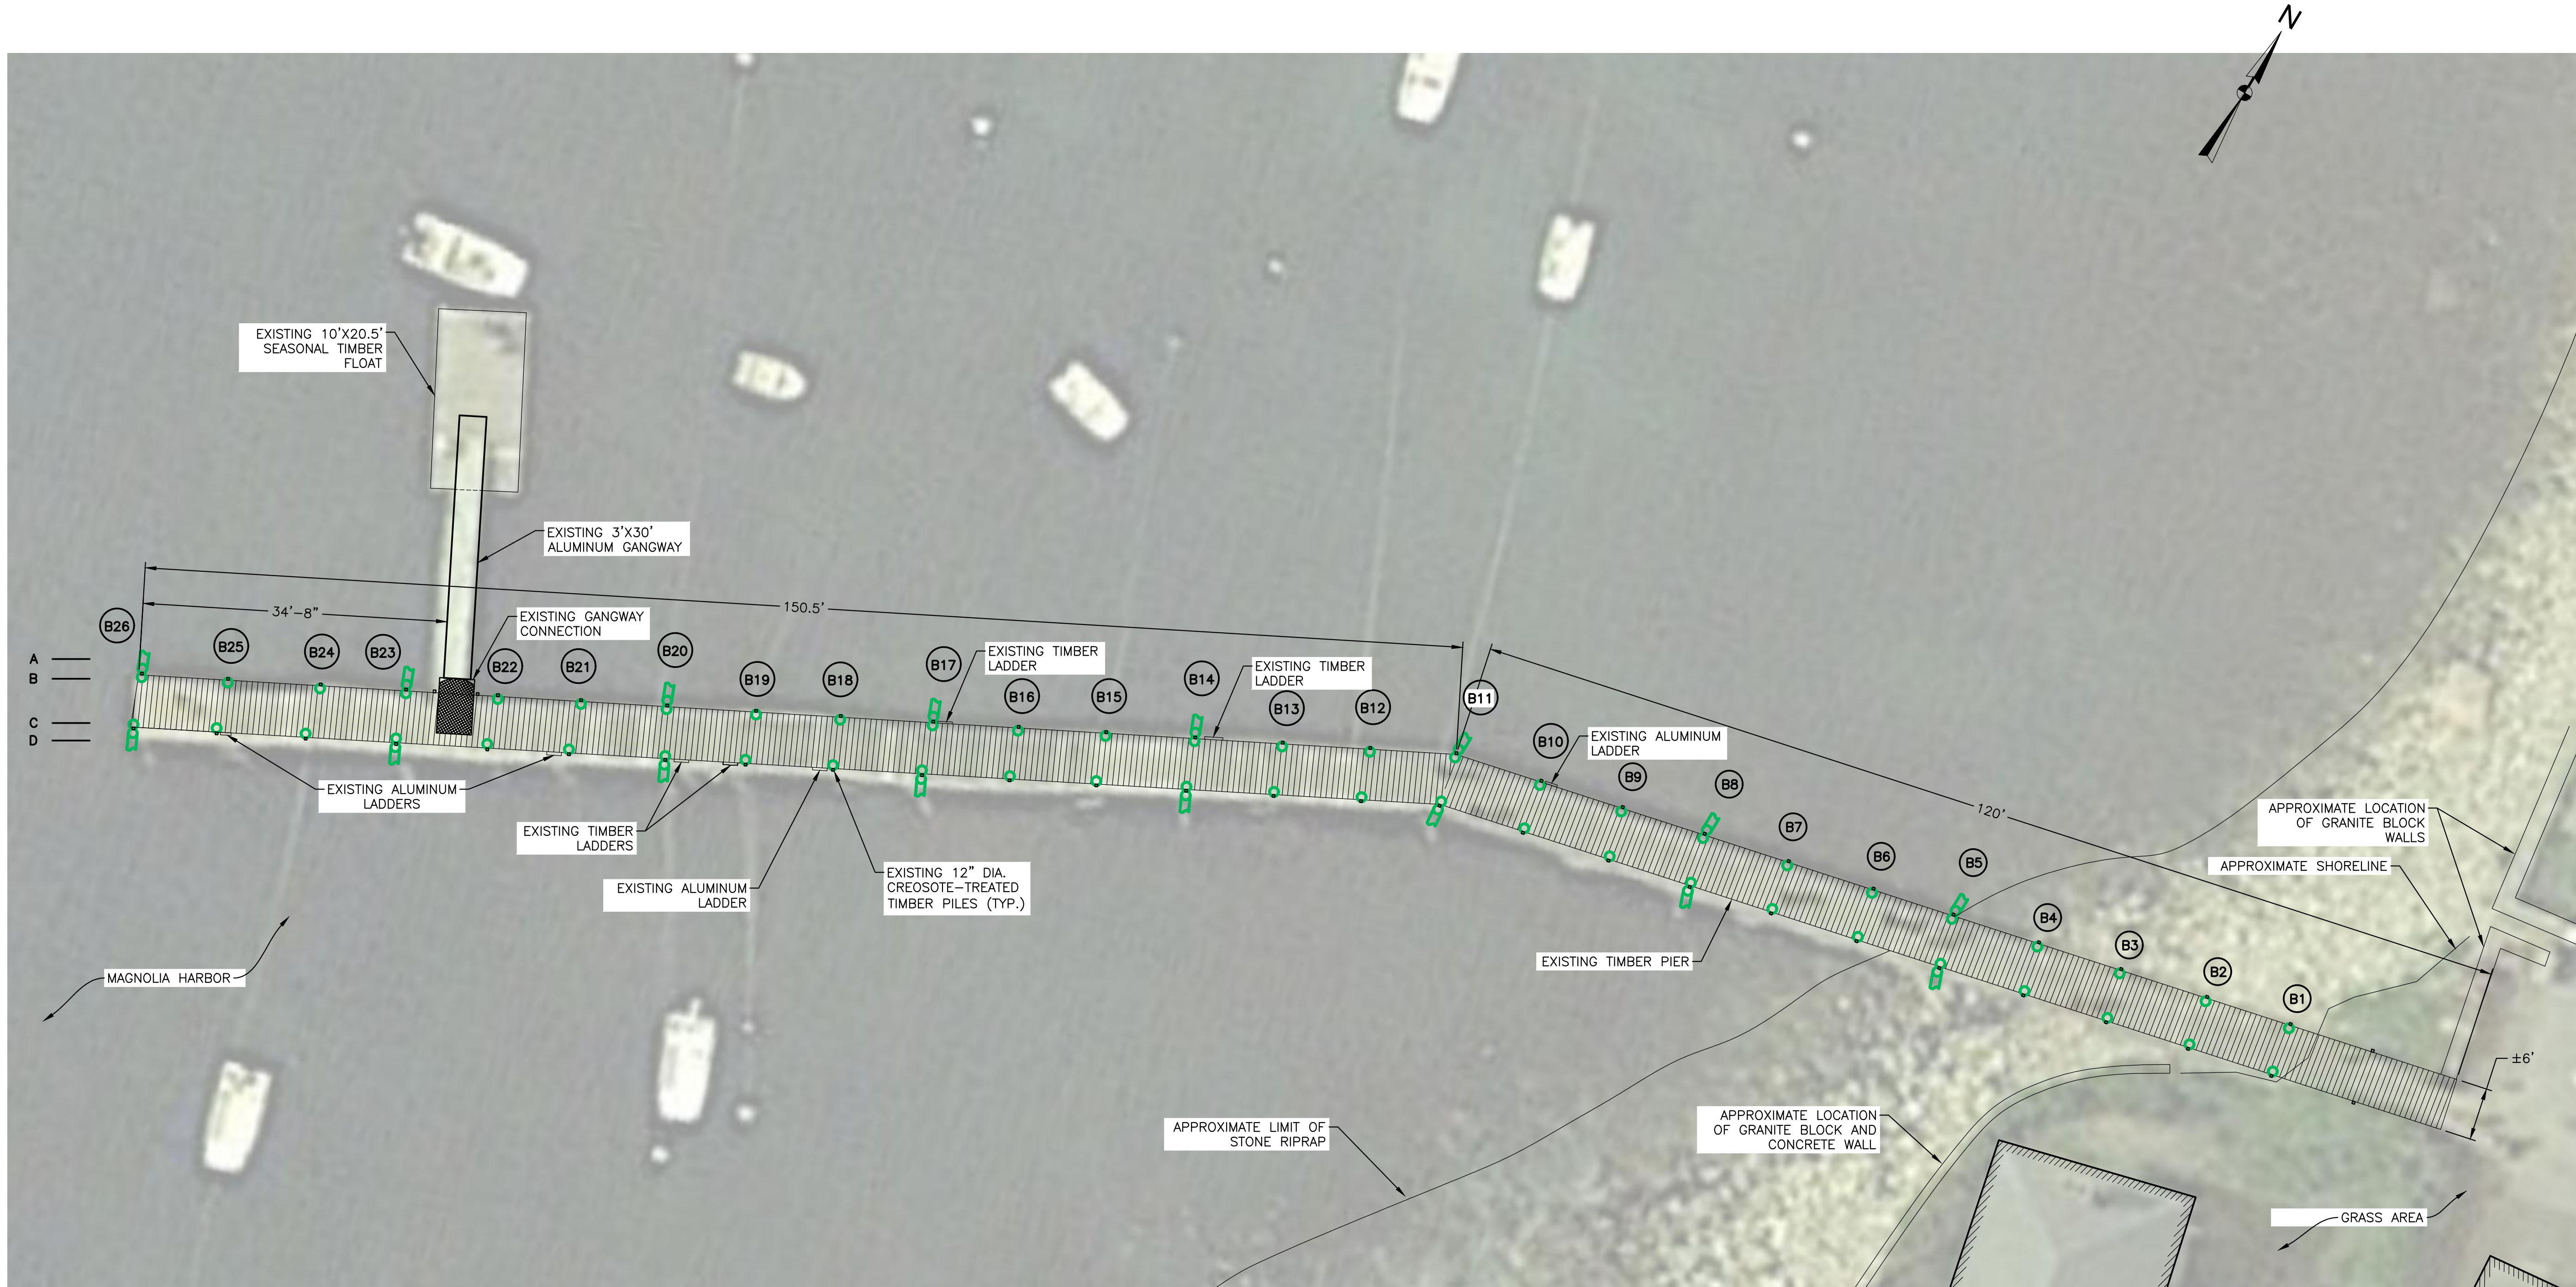
| NO. | | ISSUE/DESCRIPTION | BY | DATE |
|---|---|---|---|---|
| PROJ MGR: DAS | DESIGNED BY: DAS | REVIEWED BY: ABB | CHECKED BY: RKT | FIGURE 1 |

The observations below are based on above-water and underwater inspections of the Magnolia Pier performed on May 22, 2018. A reference plan of the structure is included in Figure 1 in **Appendix C** of this report.

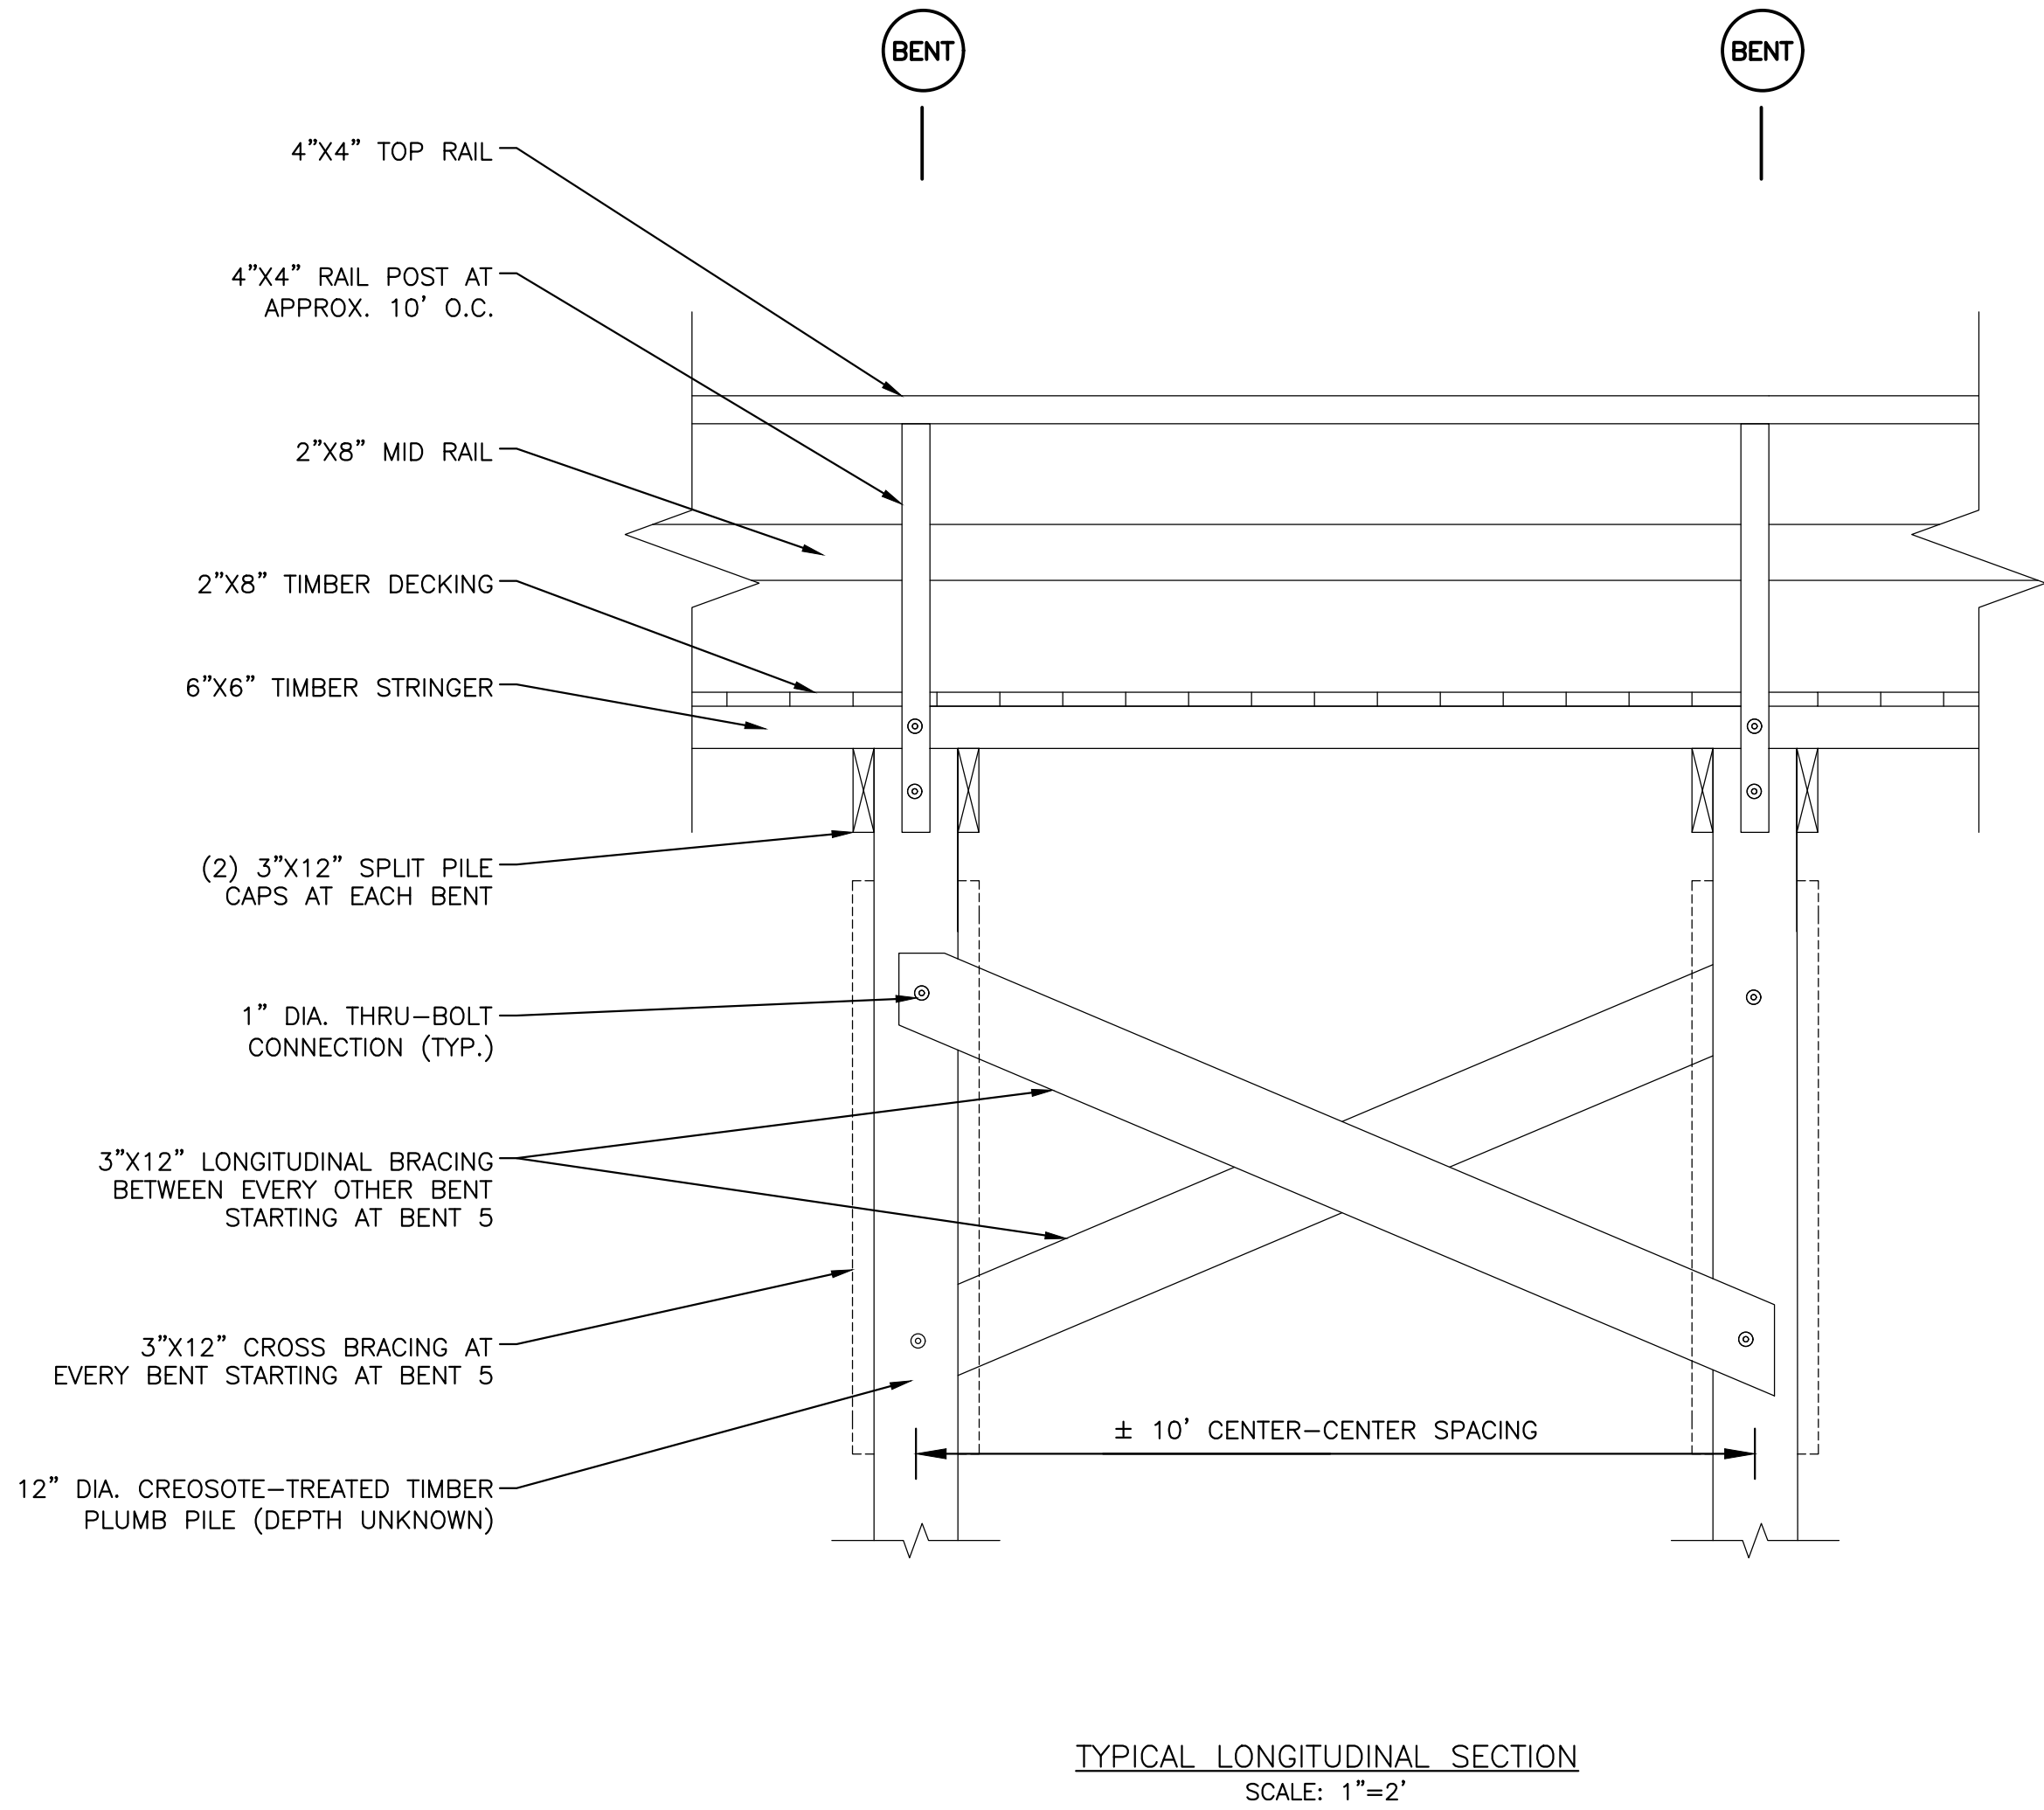
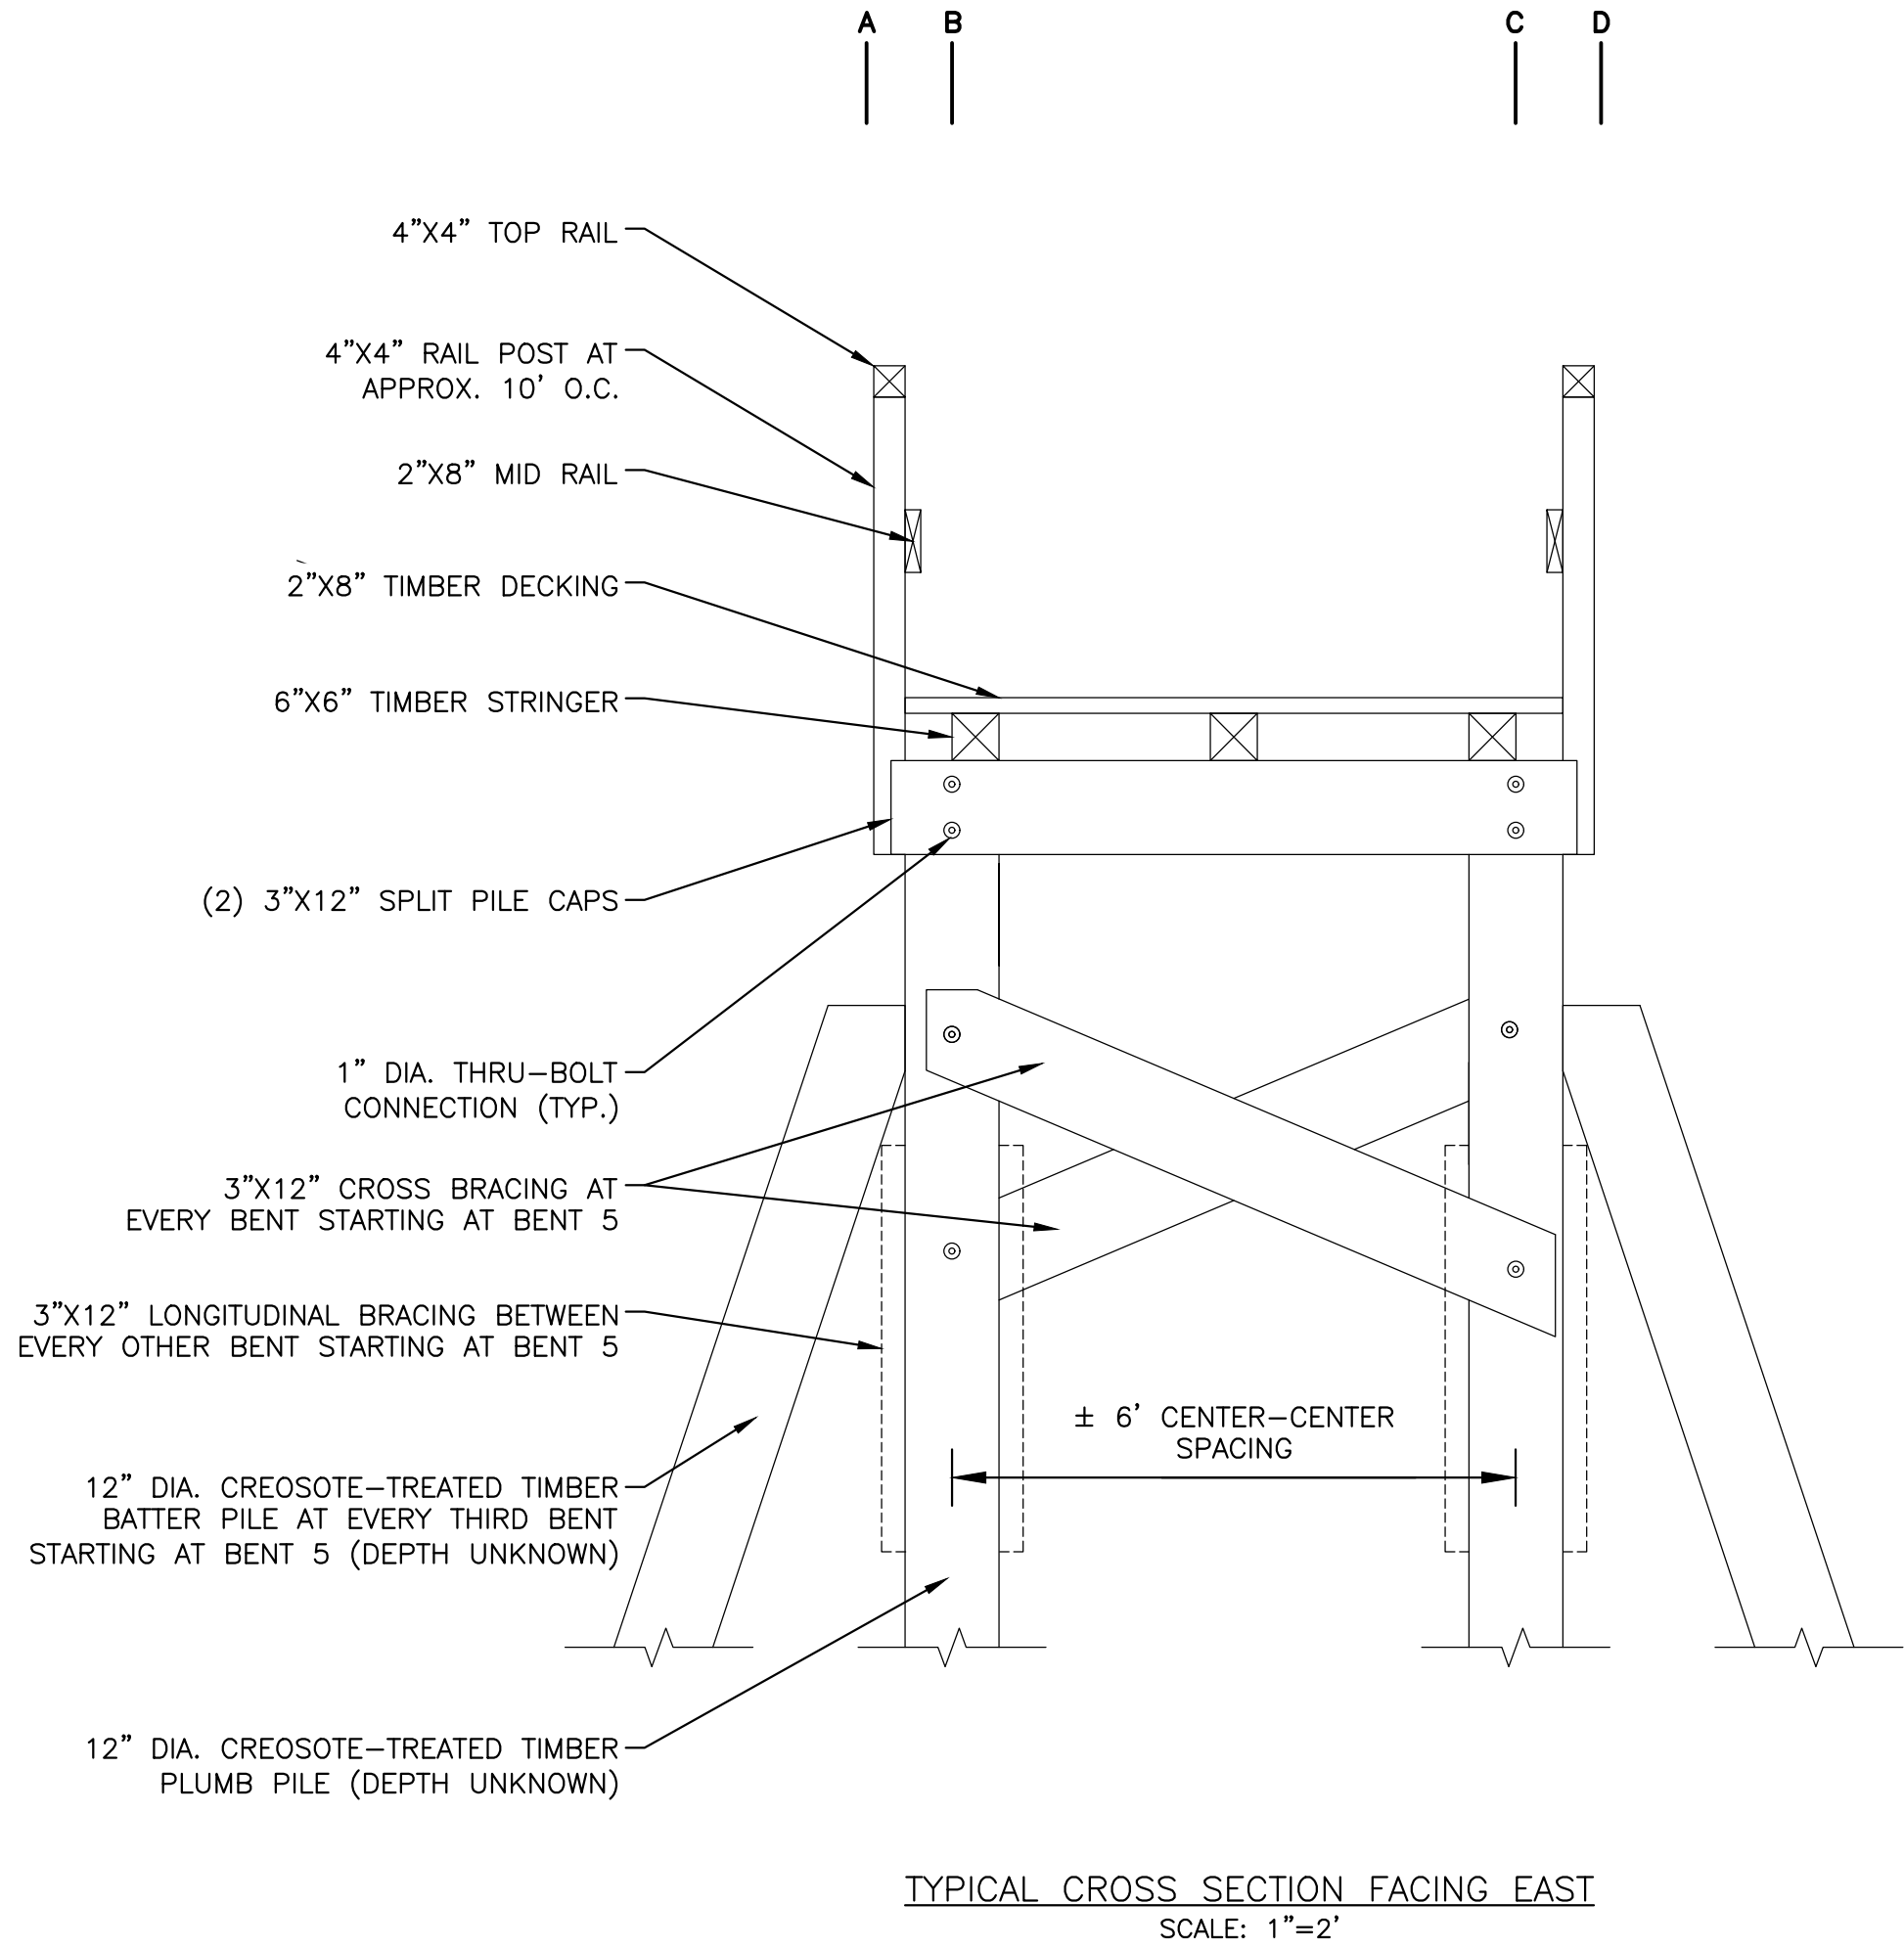
| NO. | | ISSUE/DESCRIPTION | | BY | DATE |
|---|---|---|---|---|---|
| PROJ MGR: | DAS | REVIEWED BY: | ABB | CHECKED BY: | FIGURE 2 SHEET NO. 2 OF 2 |

The pier framing is composed of (2) two 3-inch by 12-inch timber split pile caps per bent, (3) three 6-inch by 6-inch timber stringers spaced at 2.5 to 3 feet on center, 3-inch by 12-inch timber cross-bracing and longitudinal bracing, and 2-inch by 8-inch timber decking. The pier railing is composed of 4-inch by 4-inch timber posts spaced at approximately 10 feet on center, 2-inch by 8-inch timber mid rail and 4-inch by 4-inch timber top rail. A reference site plan schematic (Figure 1) and typical pier sections (Figure 2) are presented in **Appendix C**.
